Steel Frame - Concrete Slab Composite Floor Fire Resistance Experiment[†]

Serdar SELAMET¹
Taygun Firat YOLAÇAN²

[†] Published in Teknik Dergi Vol. 28, No. 3 July 2017, pp: 8007-8022

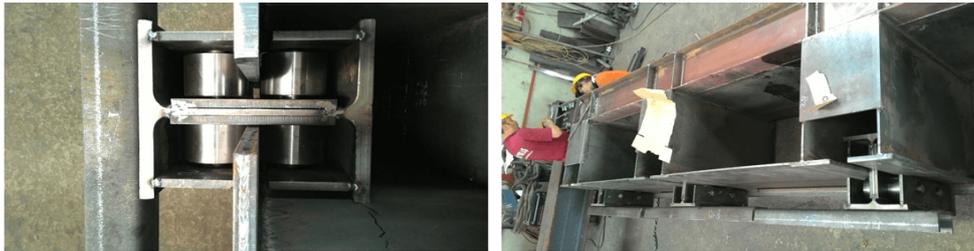
In the scope of this study, a fire resistance test mechanism, which is horizontally fixed, vertically free and capable to transfer moments, that resist tension and compression forces, is innovated. The CAD drawing and final manufactured product of the mechanism are shown in Figure – 2 and Figure – 4, respectively. This invention has a pending patent application from Turkish Patent Office [20].

Figure 4. Linear bearing system which is horizontally fixed, vertically free and capable to transfer moments of the connection mechanism that satisfy symmetrical boundary condition.

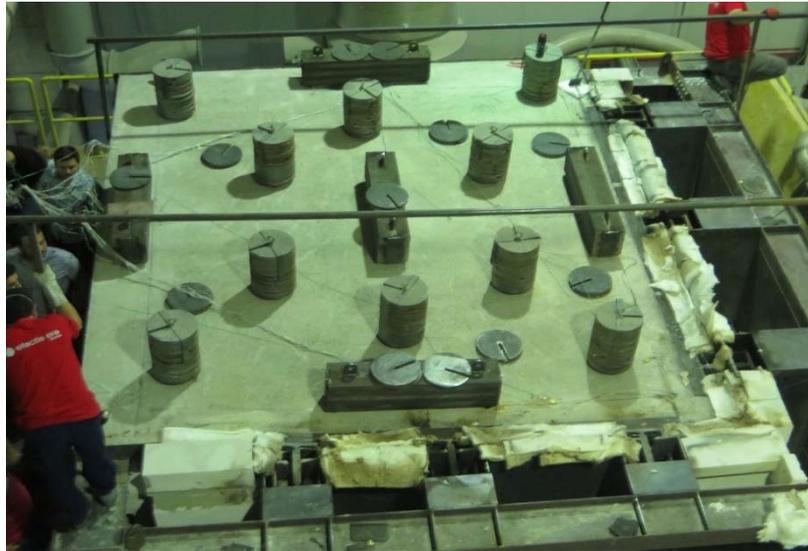
Equation – 1 represents the load combination that should be applied for structural fire design of office type buildings according to Eurocode (EC1). In Equation 1; w , Q and G are total design load, live loads and dead loads, respectively [21]. The live load Q is applied uniformly to the concrete slab surface with a magnitude that equals 2.5 kN/m^2 as deemed appropriate Eurocode Standard (EC1). The uniform load distribution is achieved with 10 pieces of 200 kg weight, 5 pieces of 375 kg weight and 13 pieces of 20 kg weight as shown in Figure – 7.

Figure 7. The loading condition on the composite floor system before the experiment.

Once the gravity loading shown in Figure – 7 was applied to the floor system, 45 mm displacement was recorded at the symmetrical perimeter corner. The deflections are shown in Figure – 11. The negative (-) values on Figure – 11 represent vertically downward displacement after setting the deflection due to gravity loading to zero (e.g. base correction). It can be seen from Figure – 11 that while the displacement around the perimeter beams remained low as expected, the region nearby symmetrical boundaries, especially the corner region (D12), displaced downward up to 50 mm during fire. The total displacement of the

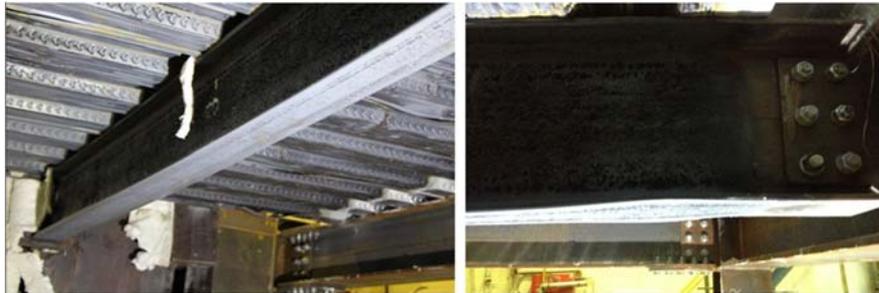
Proper performance of the connection mechanism, which satisfies symmetrical boundary conditions for the composite floor system, is validated under elevated temperatures. As it can be seen from Figure – 12 the secondary beam (IPE330) did not lose its stability, but it experienced local buckling of the bottom flange nearby the shear connection region (see Figure 3)

Figure 12. Deformed shape of the unprotected secondary beam (IPE330) and the steel deck after the test, local buckling on IPE330 beam around the shear connection.

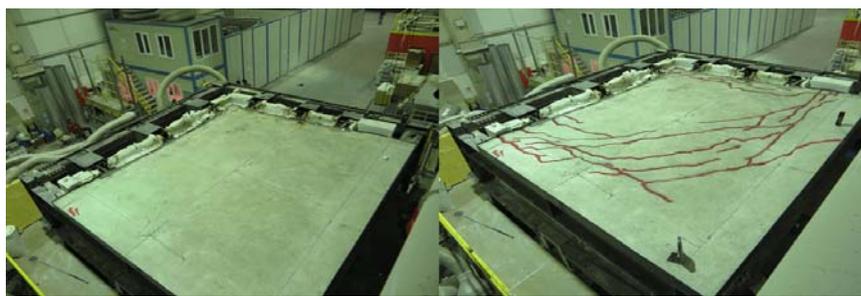
The top surface of the concrete slab before and after the fire experiment is shown in Figure 13a-b. Gradually increasing deflection towards the symmetrical perimeters resulted tension zone in the slab and caused cracks on the concrete surface. These cracks are the proof of the membrane action mechanism of the concrete slab.

Figure 13. (a) The top surface of the concrete slab system before the experiment, (b) concrete cracks after the experiment (highlighted in red), (c) illustration of the tensile membrane action.
